The Lake Alpine Water Company (LAWC) owns and operates a potable water treatment and distribution system in the unincorporated community of Bear Valley, Alpine County, California. The LAWC is proposing to replace and upgrade the existing treatment system with a new granular activated carbon filter and limestone contact system. The proposed replacement and improvements under the Lake Alpine Water Company Granular Activated Carbon and Limestone Improvements Project (project) would include:

LAKE ALPINE WATER COMPANY
GAC AND LIMESTONE CONTACT SYSTEM REPLACEMENT PROJECT
PRELIMINARY ENGINEERING REPORT

Date: May 3rd, 2024
By: Allison Prater, P.E.
 Joe Riess, P.E.

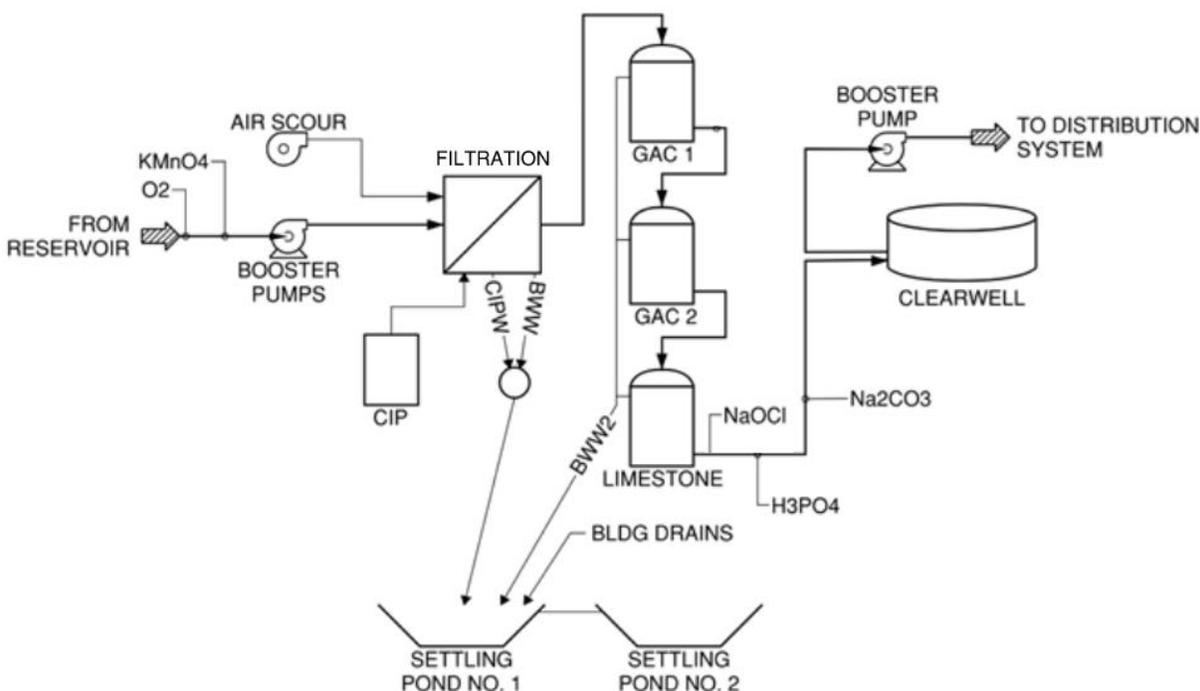
Figure 1. Existing Lake Alpine Water Treatment Plant Process Flow Diagram

A process flow diagram of the existing water treatment system is shown in Figure 1. **Error! Reference source not found.**

The existing water treatment plant has the following main liquid stream treatment processes:

2. Potassium Permanganate (KMnO_4) addition for the oxidation of iron and manganese. Following KMnO_4 addition, oxidation occurs in the approximately 100-ft of 8" diameter pipeline between the feed point and the filter feed pumps for the filtration system. This contact volume is approximately 260 gallons, which gives a contact time which varies from 45 seconds to 3 minutes over the plant flow range from a low flow of 80 gpm to the plant design flow rate of 336 gpm. KMnO_4 dose ranges from 0.2 to 9.0 mg/L, depending on raw water conditions.

4. Following filtration, water is conveyed through two GAC systems operated in series.
5. The limestone contactor is used to add hardness to the water. Empty bed contact time (EBCT) ranges from 10 to 45 minutes over the plant flow range of 80 gpm to 336 gpm. Recommended EBCT for limestone contactor is 20 to 45 minutes. To achieve 20 minutes of contact time, the maximum flow through the limestone contactor would be 180 gpm.

7. Phosphoric Acid (Orthophosphate, H_3PO_4) is added for corrosion control in order to combine with metal pipe materials (iron and copper) and develop and maintain a protective film on the interior of distribution system and in-house piping to prevent lead and copper corrosion. Typical dose is 2 mg/L.

8. Soda Ash (Na_2CO_3) is added to increase pH and reduce the corrosivity of the water. A dose of 27 mg/L is typical and generally results in increasing the pH from a raw water pH of approximately 6.5 to a finished water pH of approximately 8.0.

1. Oxygen addition at the lake intake (oxidize iron and manganese)
2. Chemical pretreatment using potassium permanganate (oxidize iron and manganese)
3. Filtration (remove oxidized iron and manganese)
4. Granular activated carbon (reduce total organic carbon)
5. Limestone contact (increase hardness)
6. Sodium hypochlorite (onsite generated) addition (disinfection)
7. Soda ash addition (pH adjustment)
8. Phosphoric acid addition (corrosion control)
9. Settling ponds for backwash waste and building drains

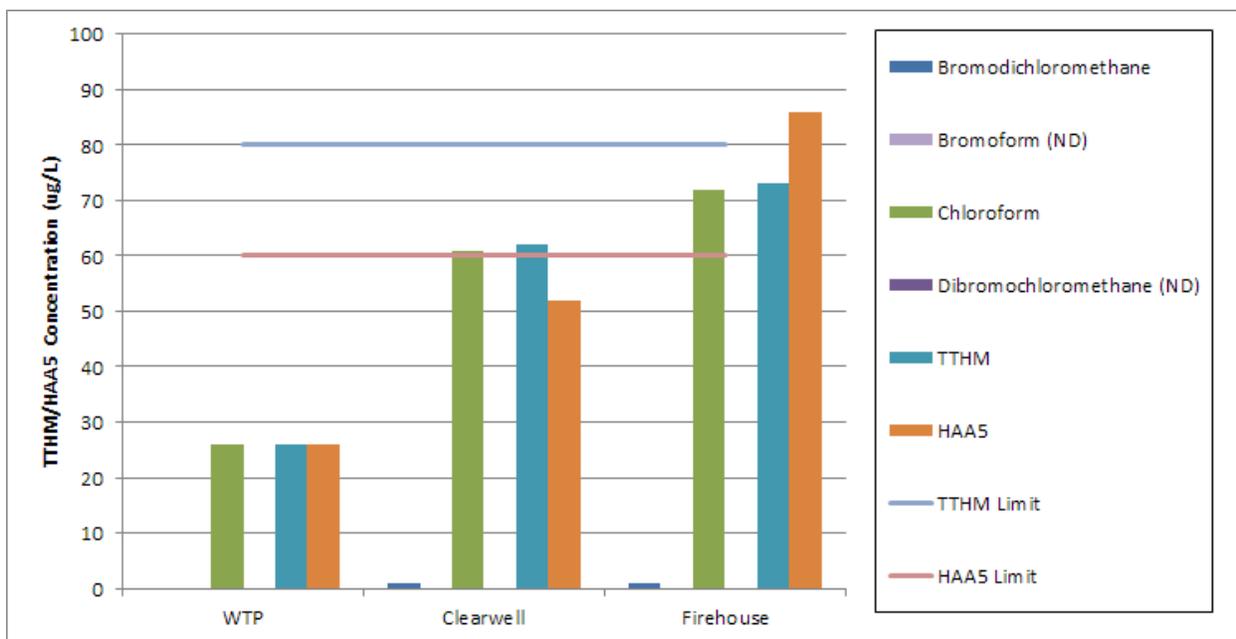
Figure 2: TTHM/HAA5 Formation in Lake Alpine Water Company Distribution System, July 17, 2013

Disinfection byproduct formation (total trihalomethanes, TTHM and haloacetic acids, HAA5) has been a historical challenge for the Lake Alpine Water Company. The combination of moderate TOC (DBP formation is most prevalent at TOC >2 mg/L) and long water ages is leading to formation of TTHM and HAA5 at or above the regulatory limit. Typical DBP formation in the system, as measured on July 27, 2013 is shown in Figure 2. This data shows several items of note:

- Both TTHM and HAA5 are formed significantly in the Clearwell, prior to even entering distribution. Approximately 85% of the TTHM and 60% of HAA5 are formed before leaving the Clearwell. Given the size of the Clearwell (200,000 gallons) and typical residence time (the minimum residence time is approximately 3 days during August demand of 2,000,000 gallons/month, maximum residence time is 20 days during April demand of 300,000 gallons/month), this is not surprising.
- Almost all of the TTHM being formed is chloroform.

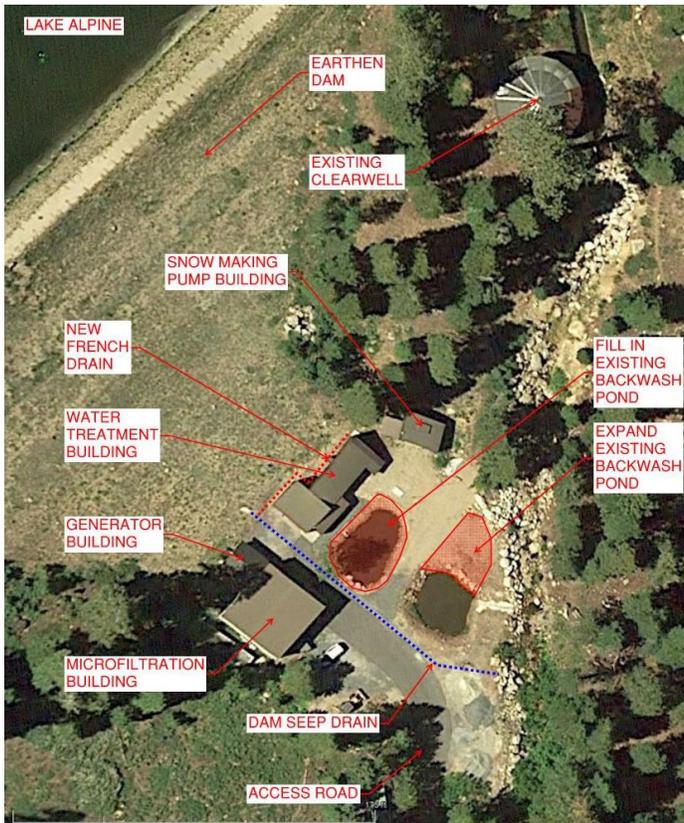
Figure 3: Site Plan

A site plan for the proposed facilities is shown in Figure 3. The proposed GAC and Limestone vessel arrangement is shown in Figure 4.

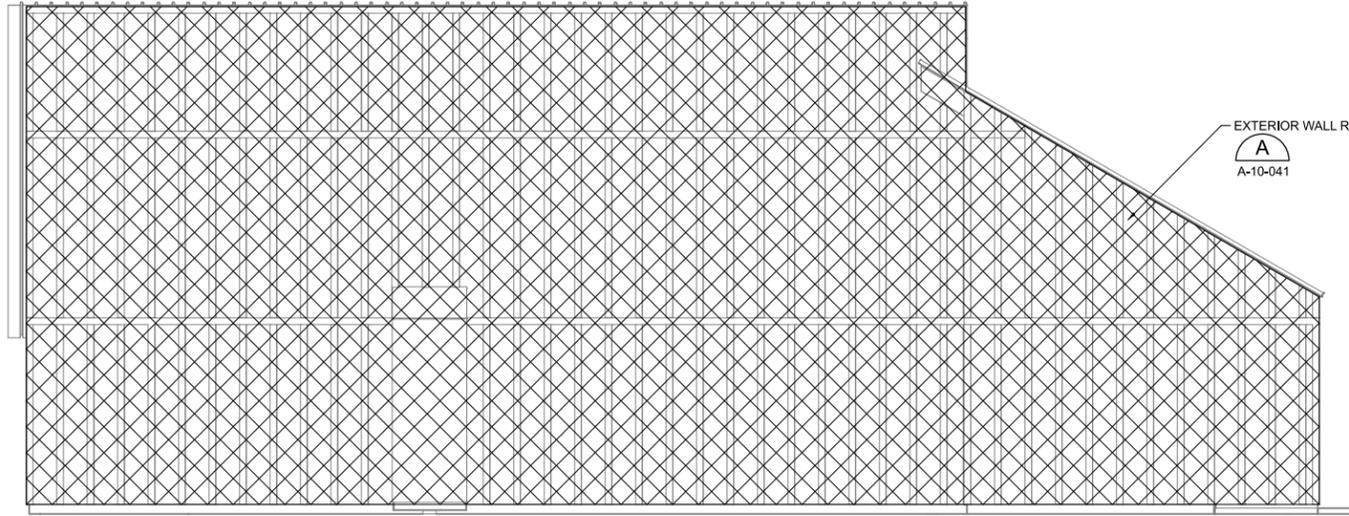
A REAR (WEST) ELEVATION
A-10-041 1/4"=1'-0"

ARCHITECTURAL
EXTERIOR WALL
WEATHERPROOFING IMPROVEMENTS

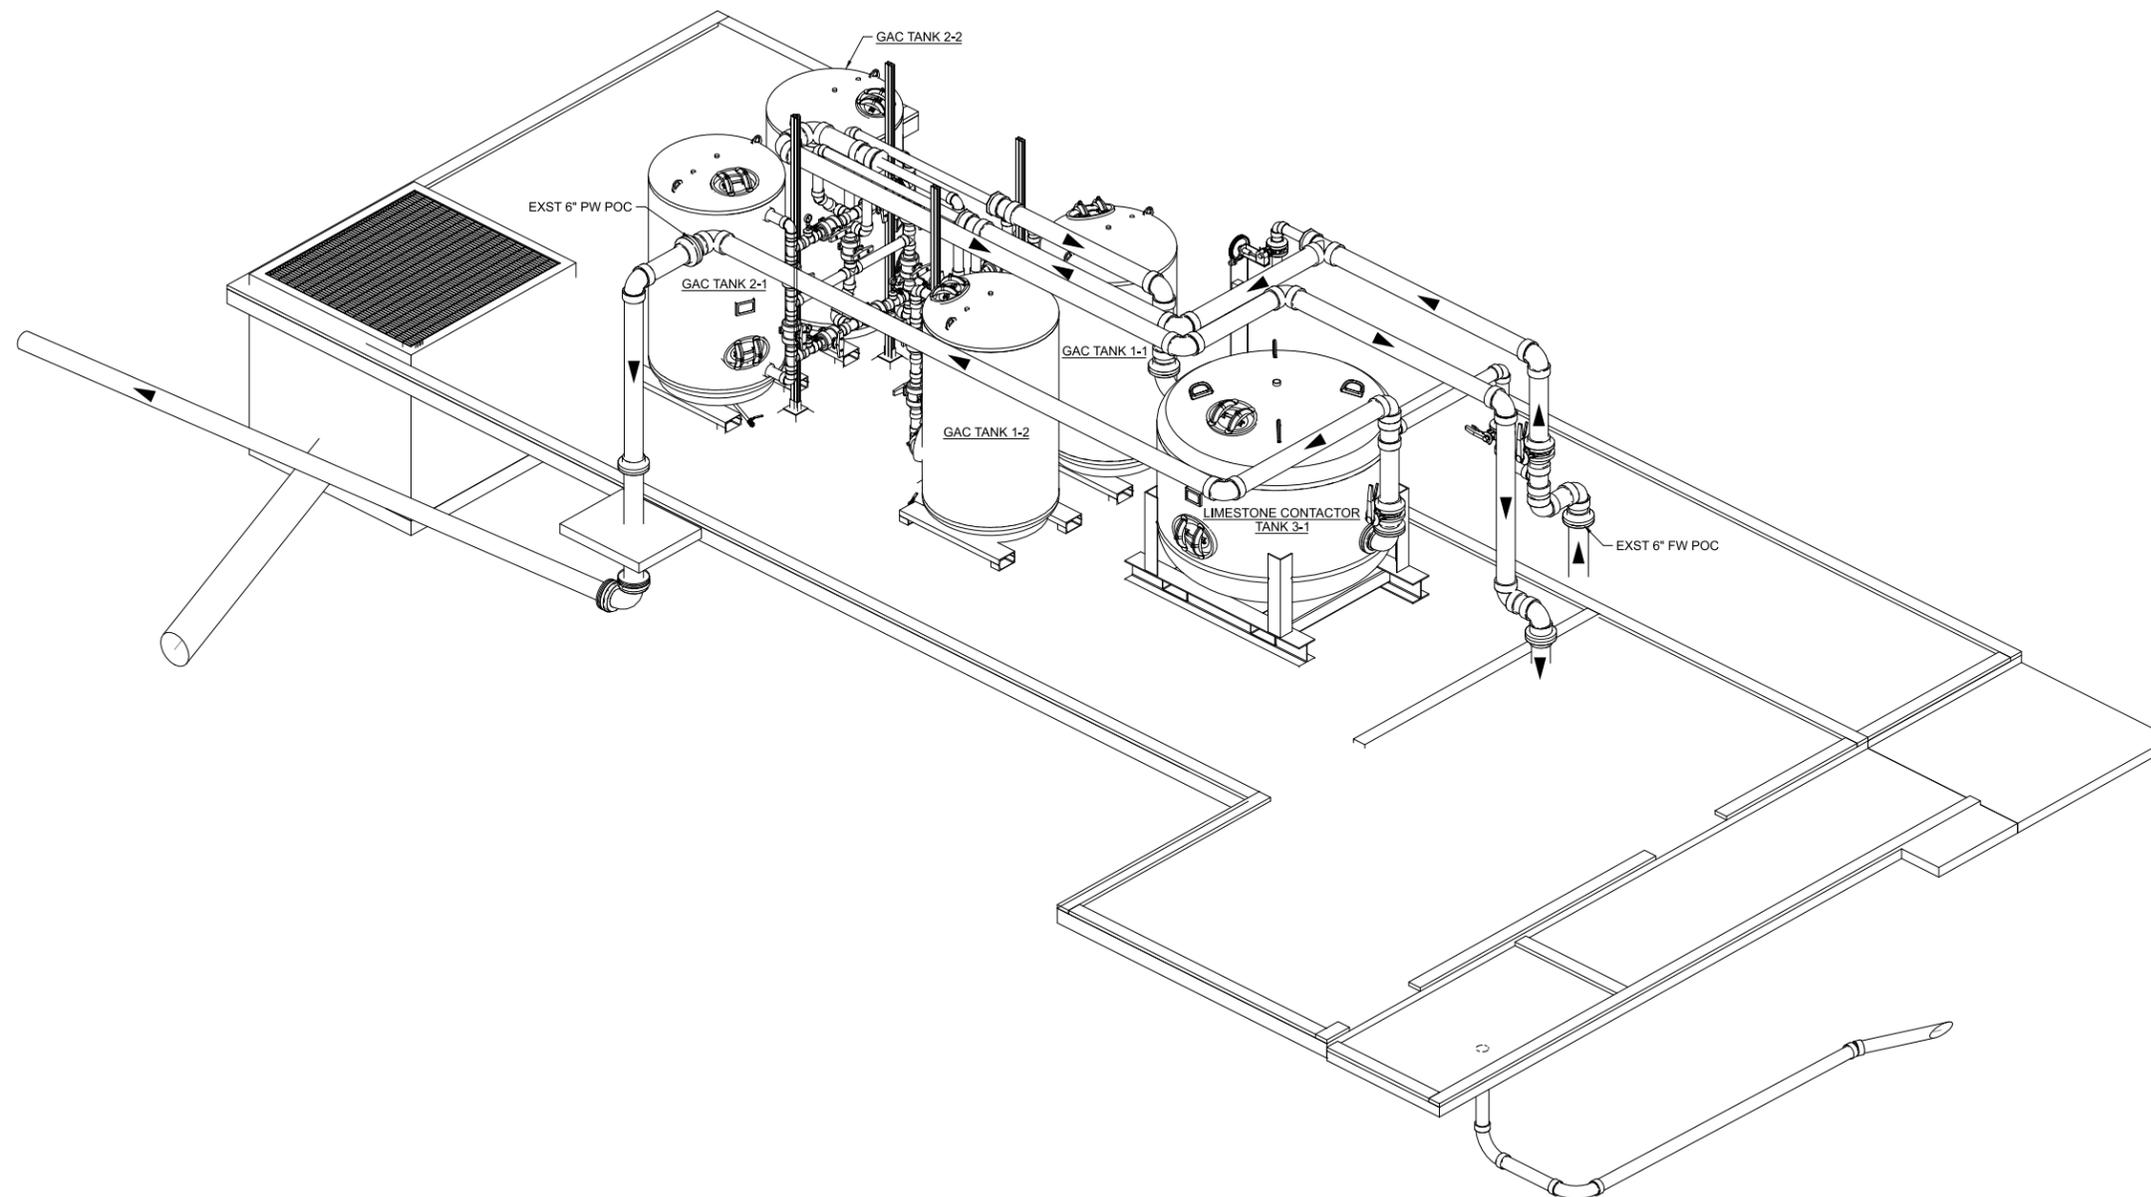
2 ISOMETRIC
M-10-101 NTS

MECHANICAL
GAC AND LIMESTONE SYSTEM
ISOMETRIC NO. 2

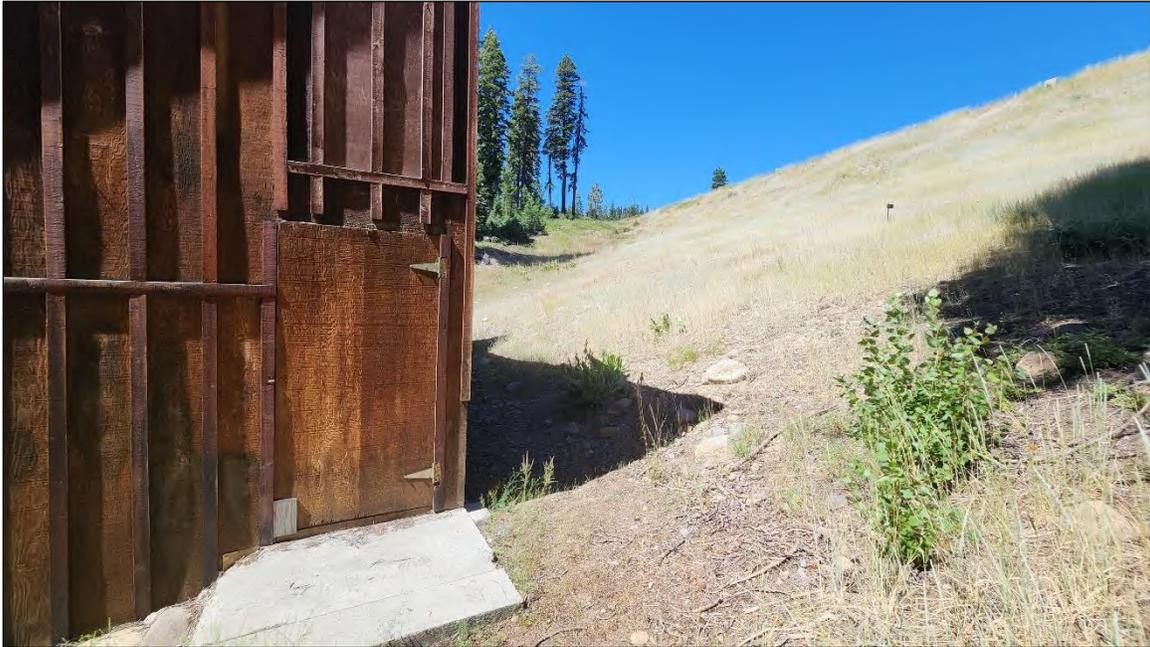
Photo 3. Representative view of the dam for Bear Lake that abuts the Study Area. Photo date 8/8/2024.

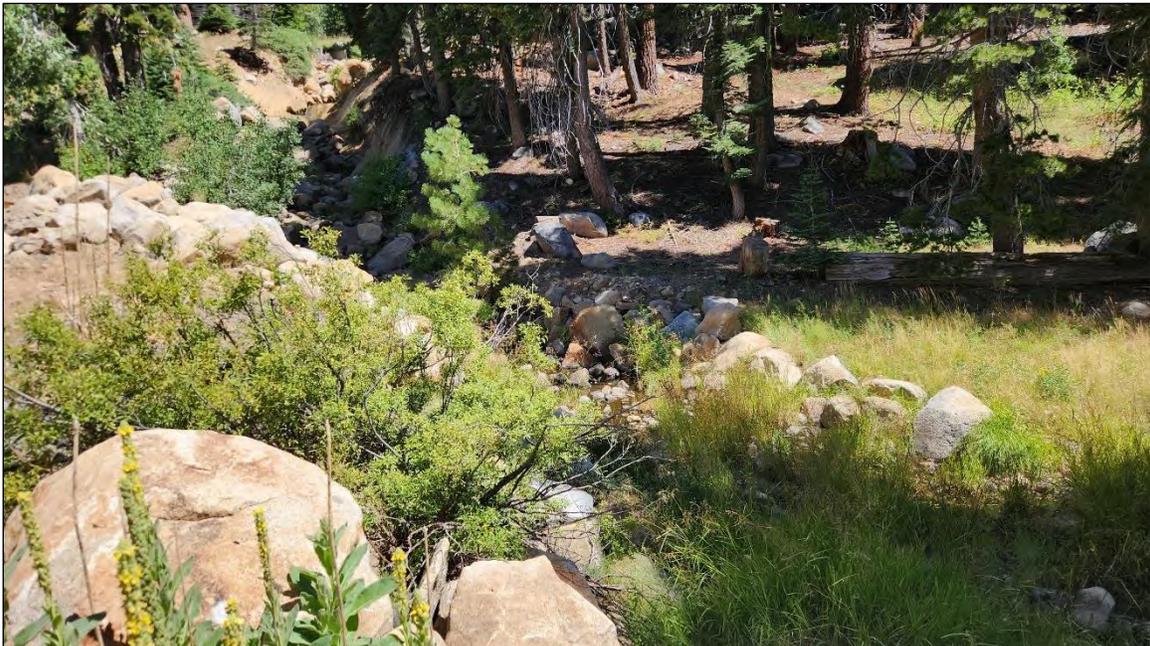
Photo 4. Representative view of drainage adjacent to the Study Area. Photo date 8/8/2024.

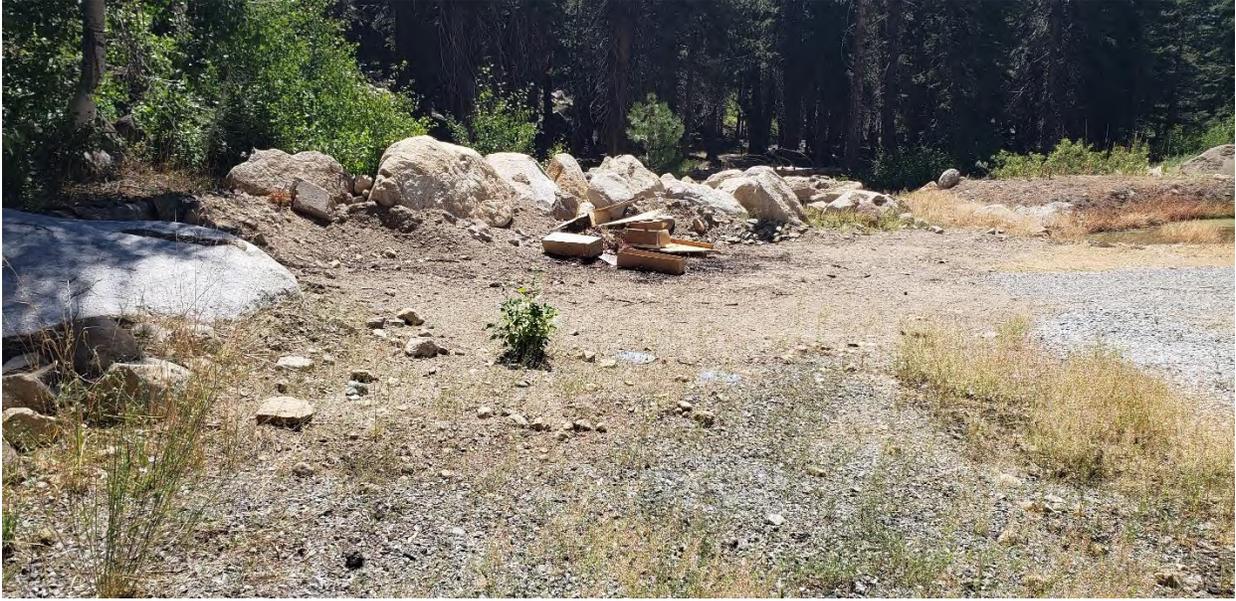
Photograph 1. View of Gravel Driveway/Work Area and Artificially Placed Stones located on Western Bank of Unnamed Creek which lies outside of the APE, facing southeast, taken 8/8/24.

The topography of the APE slopes down towards the south. Just east of the APE is Bear Creek, a small seasonal watercourse that flows from Bear Lake down the hill located to the APE's northeast towards the southeast, outside the eastern side of the APE. Large river worn stones have been artificially placed to armor the western bank of Bear Creek which runs along the eastern side of the APE, obscuring the natural creek bank (Photograph 1). HELIX's surveyor examined the creek bank and rocks along the western bank of the creek and found no evidence of cultural resources.

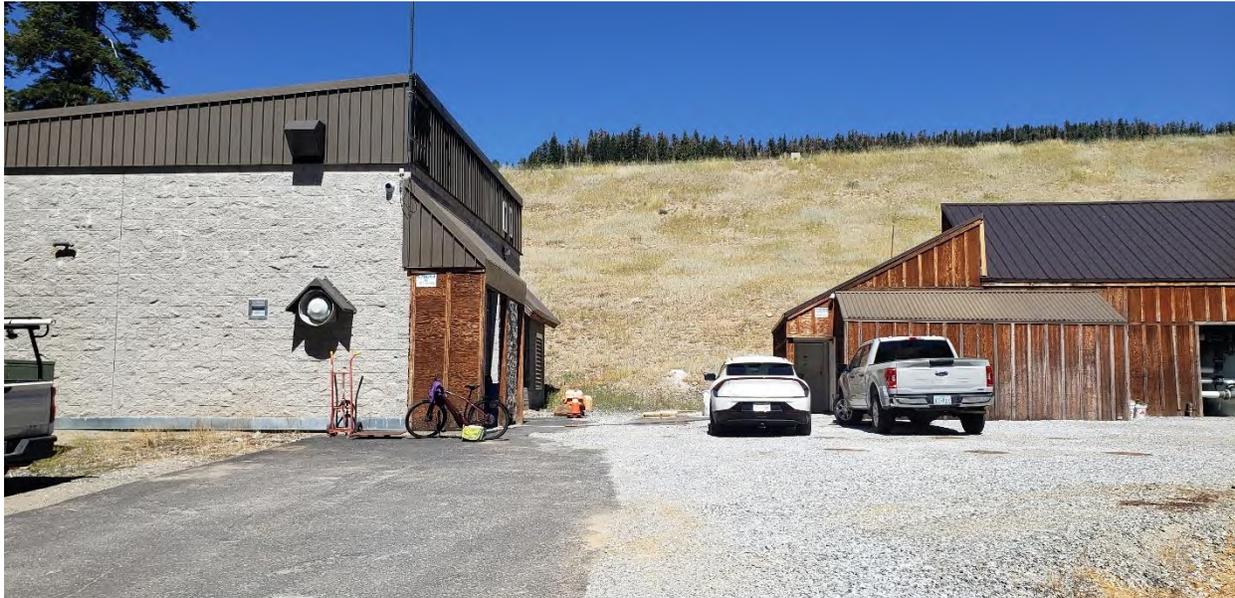
Photograph 2. APE Overview showing paved access road, Gravel Driveway/Work Area, and Two Water Filtration Structures, facing northwest, taken 8/8/24.

The ground surface of the APE is occupied by a paved access road which extends northeast from Schimke Road, a gravel driveway/work area, and two structures which house in-use water filtration equipment (Photograph 2). The gravel driveway/work area shows signs of having been heavily disturbed, including the presence of electrical utility boxes and manholes, and a metallic access vault (Photograph 3). According to Steven Schnitter, Chief Plant Operator for the LAWC, the gravel driveway/work area was once a retention pond which has since been filled in with water filtration equipment, including pumps, small reservoirs, utility lines, and imported fill (Steven Schnitter pers. comm. 8/8/24). The ground surface of the entire portion of the APE was examined for cultural resources but none were found.

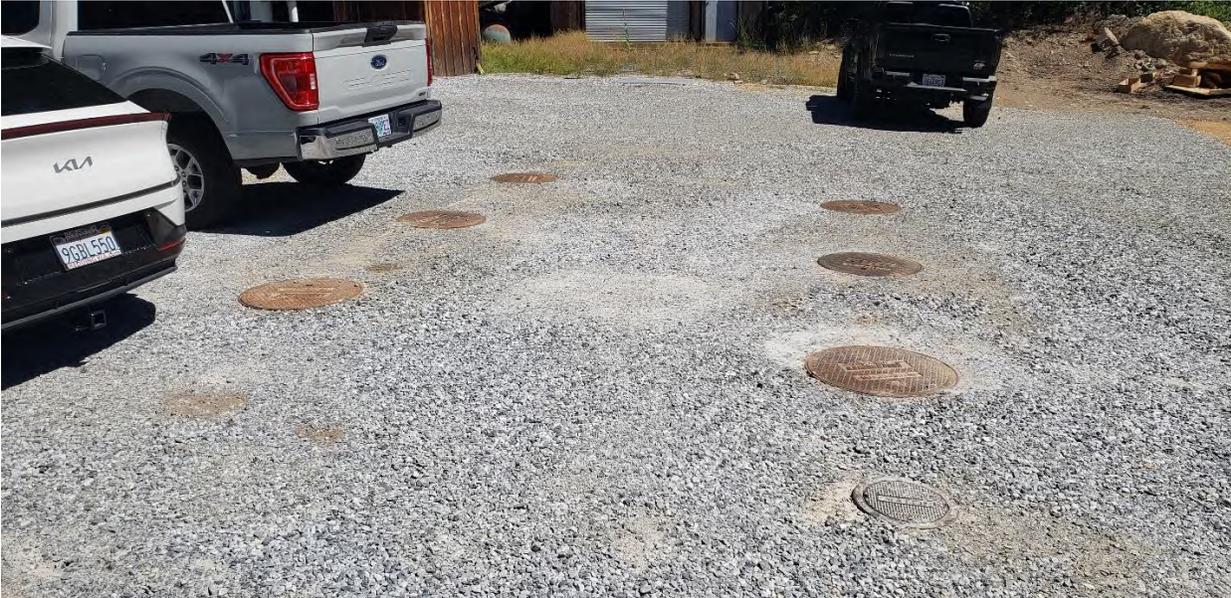
Photograph 3. View of Gravel Driveway/Work Area within Center of APE, this area has been heavily disturbed, facing northeast, taken 8/8/24.

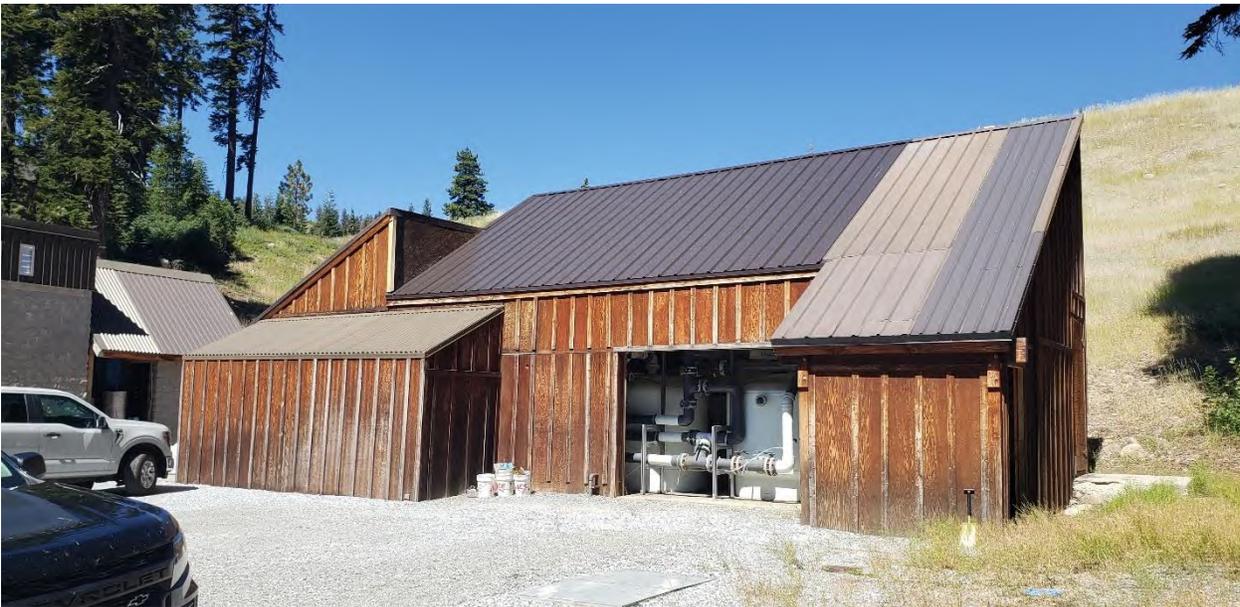
Photograph 4. View of Structure #1 within APE Which Houses Lake Alpine Water Company Filtration Systems, facing northwest, taken 8/8/24.

The field survey also confirmed the presence of two buildings in the APE which have distinct but interrelated histories. According to files kept at the Lake Alpine Water Company, the older of the two buildings is a wood-framed structure with a metal corrugated roof that was built in the summer of 1973, though the architect, designer, and builders are unknown (Photograph 4). A 1988 Engineering Report (on file with the Lake Alpine Water Company) reveals that a gas chlorinator was installed in this building in 1985. The report also refers to the structure as "abandoned" prior to the installation of this chlorinator, suggesting a period of disuse between 1973 and 1985. In 1987, the structure underwent significant modifications, with the addition of more storage space in the form of an external expansion

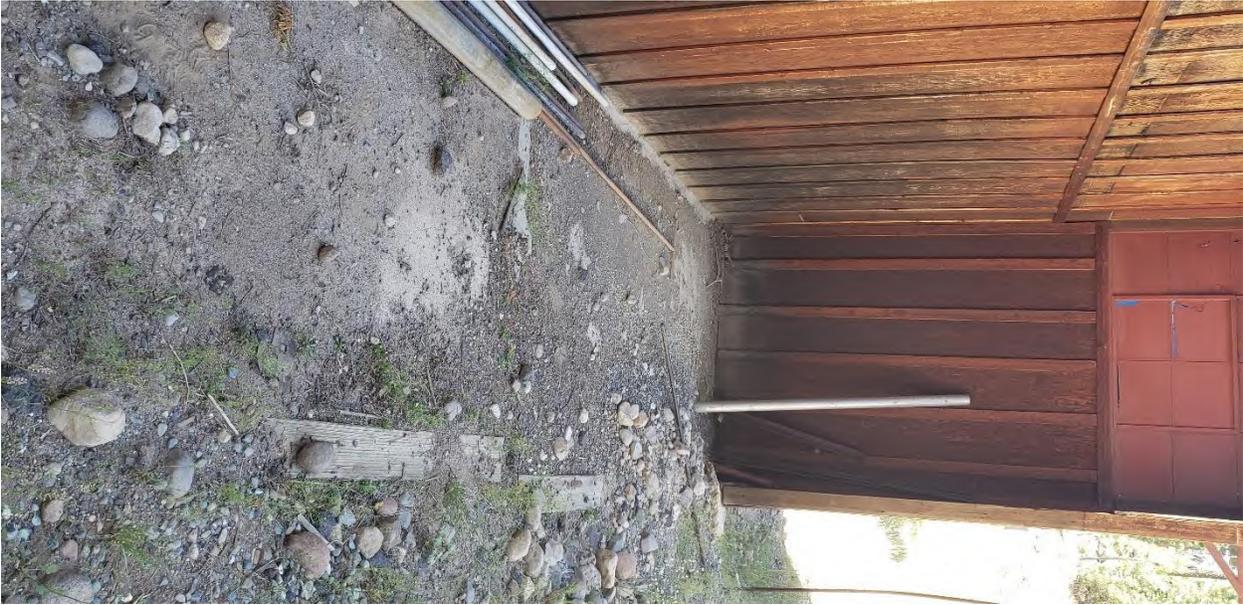
Photograph 5. View of Dam (north) Side of Structure #1, where Exterior Shelter was removed in 2005, facing southwest, taken 8/8/24.

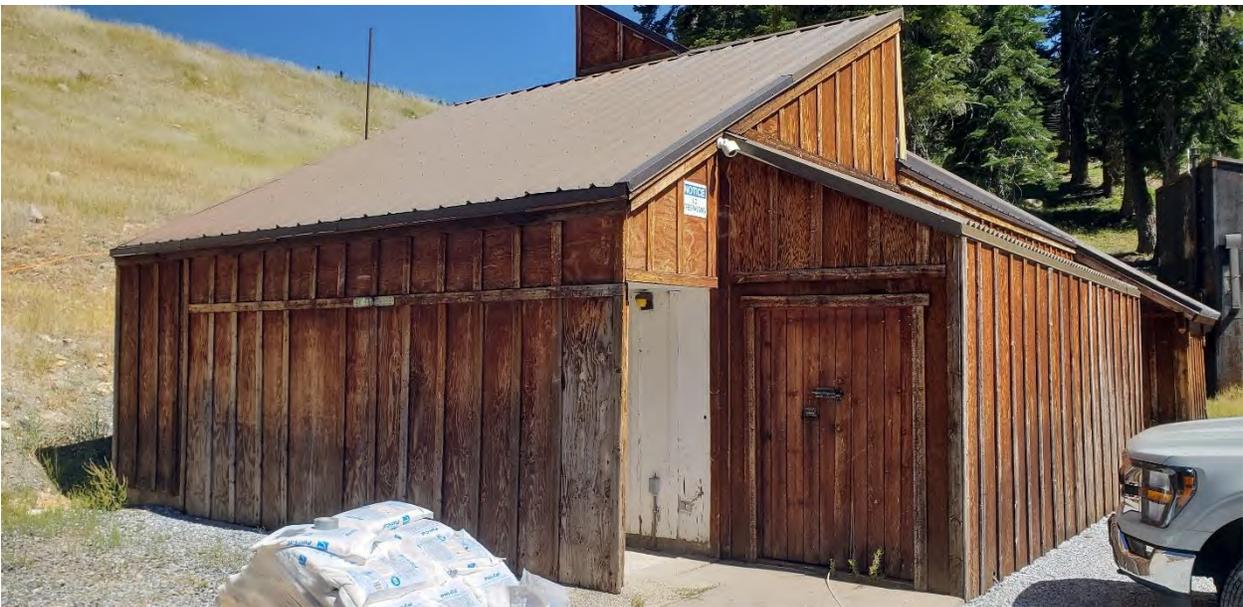
Photograph 6. View of Re-constructed Lean-to Extension on West Side of Structure #1 built in 2005, facing northeast, taken 8/8/24.

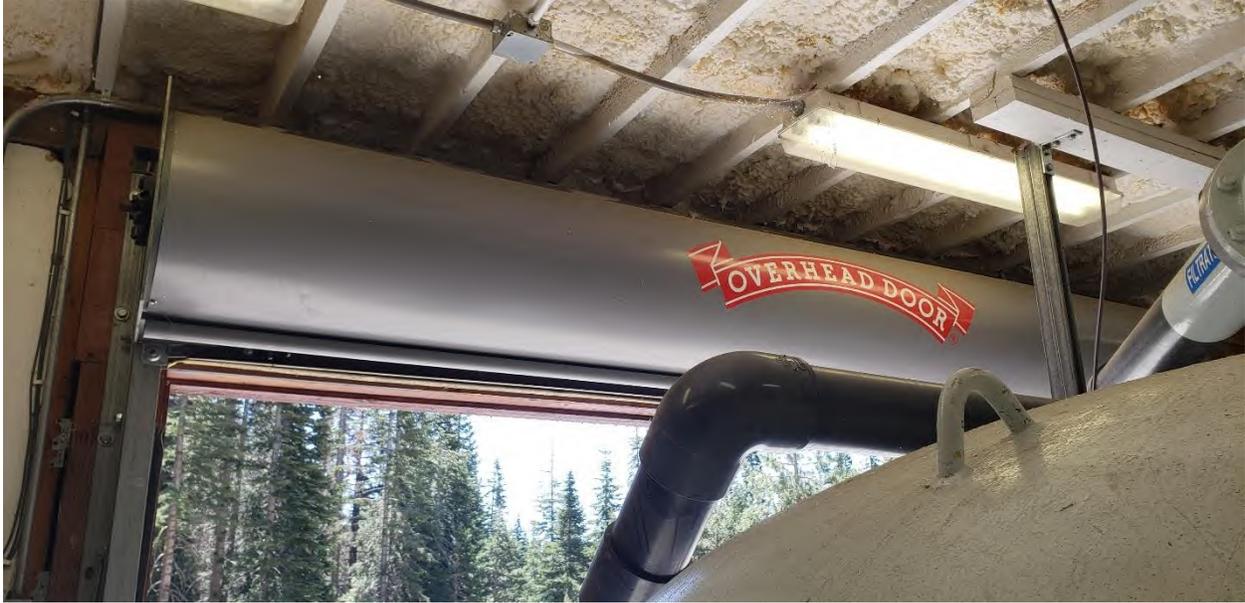
Photograph 7. View of Installed Roll Up Door on Structure #1, from Interior of Structure #1, facing southeast, taken 8/8/24.

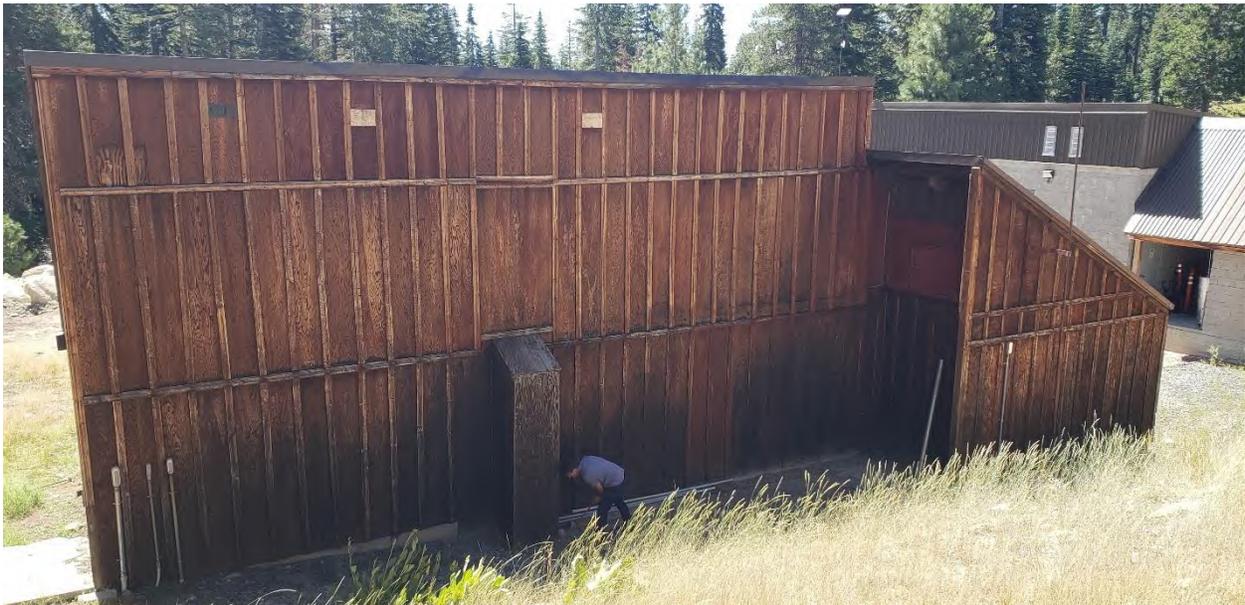
Photograph 8. View of Dam (north) Side of Structure #1 Showing Recently Installed Insulated Box Which Houses a Water Filtration Discharge Pipe, facing southeast, taken 8/8/24.

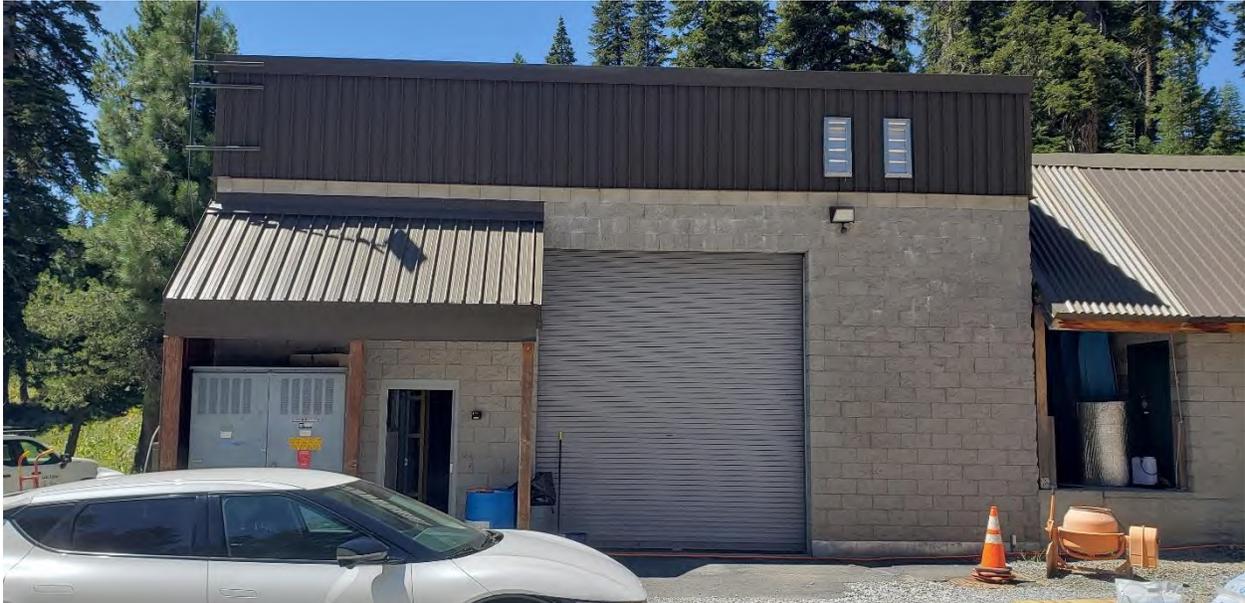
Photograph 9. View of Structure #2, built in 2005, facing west, taken 8/8/24.

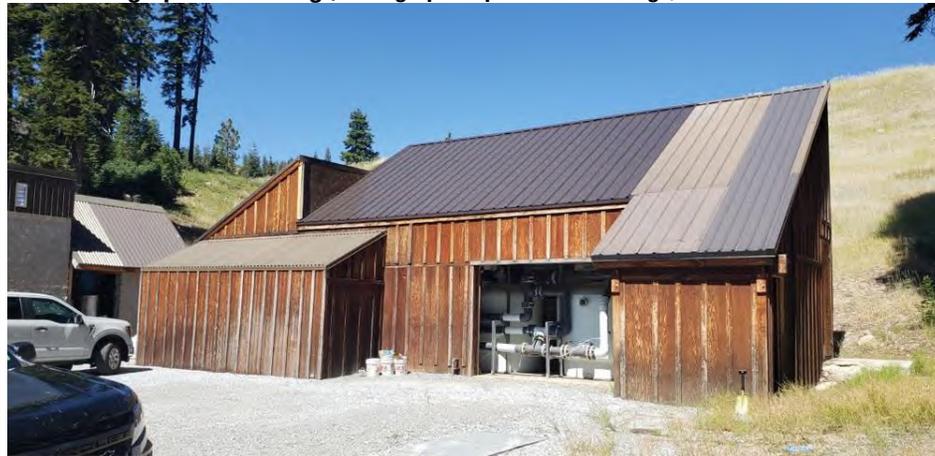
P5b. Description of Photo: (view, date, accession #) View of Structure #1 Which Houses Lake Alpine Water Company Filtration Systems, facing northwest, taken 8/8/24.

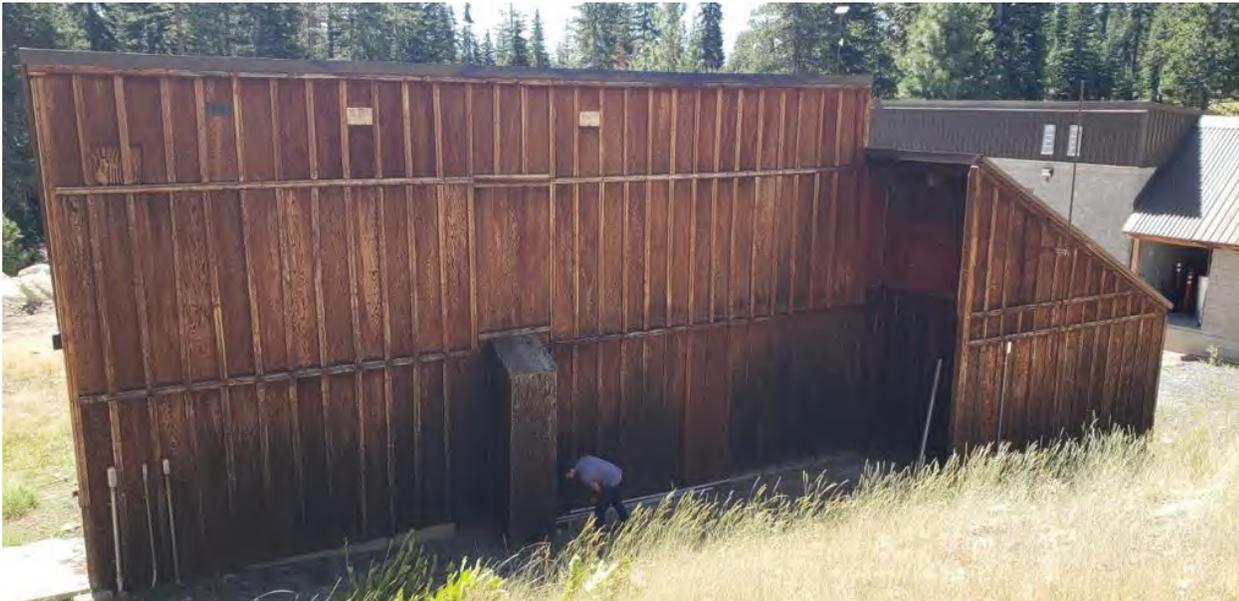
View of Backside (north) of Structure #1 Showing Recently Installed Insulated Box Which Houses a Water Filtration Discharge Pipe, facing southeast, taken 8/8/24.
